# Manhole Inspection Summary

Manhole # S43E\_\_052MH

Insp Date: **7/29/09 11:36 AM**

**Location** Address: **11 DALLAS-BETHEL-ALLEY** Cross Street: **E BALTIMORE ST**

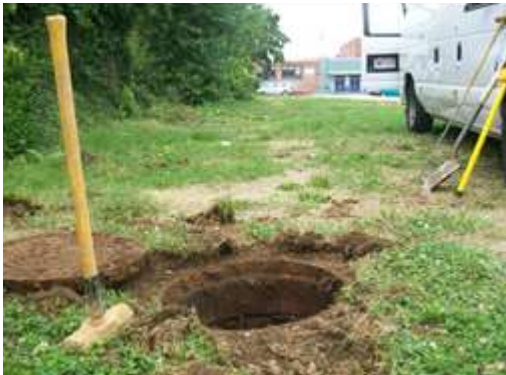
Location View

OPENNED WITH 16LB MAUL

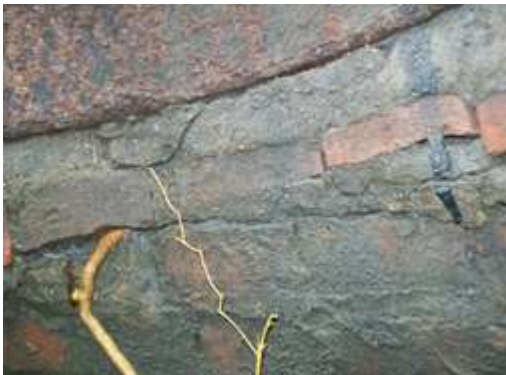
Defect 4

**Chimney / Frame Adjustment** ☒ Exists Material: **Brick** ☐ Parged Height: **4** (in.)  
Condition: ☐ Sound ☐ Cracked ☒ **Root Intrusion** ☐ Loose Brick ☐ Deteriorated  
Infiltration: ☒ None ☐ Joint ☐ Cracks ☐ Mortar ☐ Roots ☐ Wall

ROOT INTRUSION @  
CHIMNEY/CORBEL JOINT

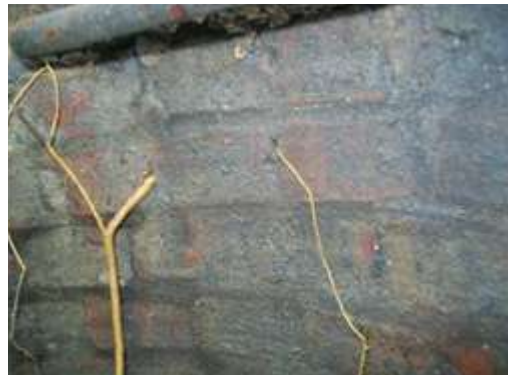
Defect 3

**Corbel** Material: **Brick** ☐ Parged Type: **Concentric/Eccentric**  
Condition: ☐ Sound ☐ Cracked ☒ **Root Intrusion** ☐ Loose Brick ☐ Deteriorated  
Infiltration: ☒ None ☐ Joint ☐ Cracks ☐ Mortar ☐ Roots ☐ Wall

ROOT INTRUSION @ CORBEL WALL

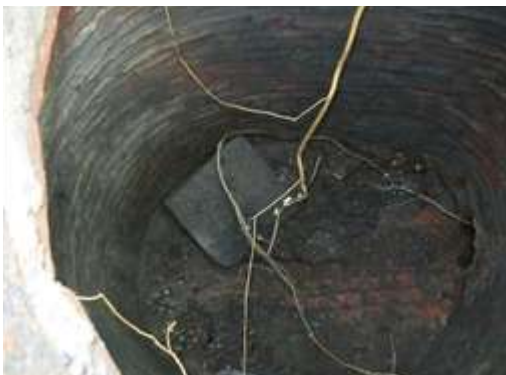
Defect 2

**Channel** Material: **Brick** ☐ Parged  
Channel Exposure: **Fully Open** Junc Dist: **0** nearest .5 ft. Azimuth: **0**  
Condition: ☐ Sound ☐ Cracked ☐ Root Intrusion ☐ Deteriorated ☐ Leaks ☒ **Debris**

DEBRIS IN TERMINAL CHANNEL

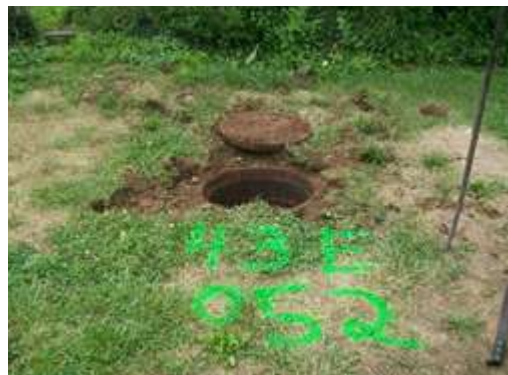
Defect 1

Comments **HOUSES HAVE BEEN DEMOLISHED AND ALLEY ABANDONED; LOCATED WITH METAL DETECTOR AND EXPOSED -2" BELOW GRADE; FORCED OPEN WITH 16LB MAUL**

Frame below grade
